PRODUCT SAFETY NOTICE

July 23, 2009

GTS® Tower Bushings Replacement

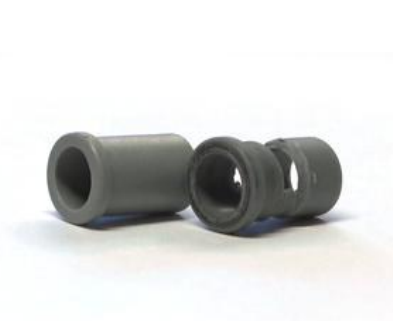
NOTE PHOTO TO LEFT:

Left Bushing is new and shows no wear. As part wears, a small groove is acceptable

Right Bushing shows extreme wear. Any penetration of the bushing thickness indicates overuse of the part and dictates immediate replacement of the part before resuming use of the equipment.

Please take some time to inspect and replace the round bushings on the rail crossbar before wear occurs that penetrates the thickness of the bushing and causes a hole or crack. If wear is present that penetrates the thickness of the bushing, causing a hole or crack, discontinue use of the equipment immediately and replace the part before resuming use.

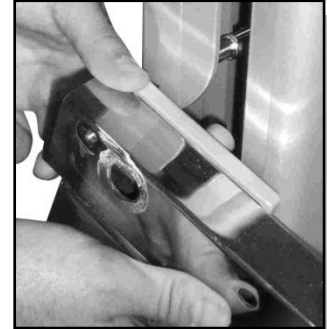
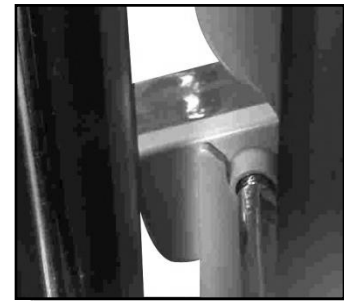
INSPECTING FOR WEAR: The round bushing resides on both sides of the rail crossbar that goes through the Tower (PHOTOS AT RIGHT). You may need to remove the LAT Bars to check thoroughly for wear.

However, if you notice significant wear by viewing the bushings through the Tower back or through the hook slots, or if you notice sticking when trying to seat the rails into the Tower hooks, we suggest that you replace the parts.

Please contact us on (NZ) 0800 552 8789 or (AUS) 1800 552 8789 to order your replacement GTS round bushings, part # 6645-02. You can also email your request to gravity@hqh.com. Units sold for commercial use have a one year warranty; if the unit(s) is less than one year old, the bushings will be sent to the customer at no cost. If the unit(s) is older than one year, there will be a small charge and postage. When you contact us, we will determine if you unit(s) are under warranty.

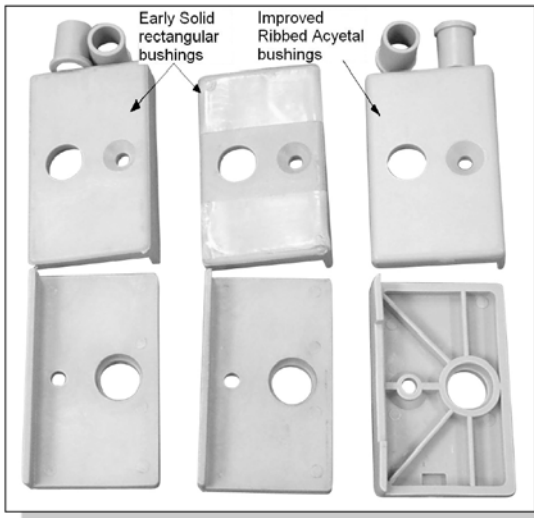
Figure 1

The bushings in the tower need to be replaced one or more times per year depending on use. The GTS has four bushing between the rails and the tower to protect the paint and chrome and to reduce noise. There are two identical rectangular bushings and two round bushings. Normally, the rectangular bushings should not wear out. However, we have discovered that in some of the early production units, the rectangular bushings may wear out prematurely. The early bushings would be solid (Figure 1) as and some may have tape stripes applied. With the longer lasting acetyl bushings, there is a notch in the bushing visible from the back (Figure 2).

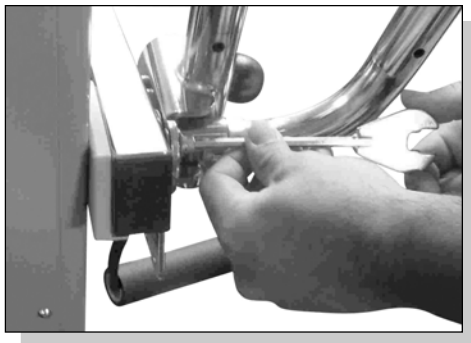
Figure 3

To replace the bushings, you must remove the LAT Bars. Use both of the two wrenches supplied with your GTS. First, remove the limit screw in the back (Figure 3) using the hex key end of one the wrenches supplied with your GTS. To remove the first nut from the shaft, loosen the first nut with one wrench while you hold the nut on the opposite side in place with the other wrench (Figure 4).

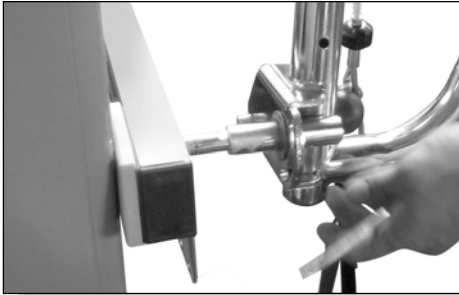
Figure 5

With one nut removed, you can remove one of the LAT Bars (Figure 5). Use the second size of the wrench to hold the shaft in place while you remove the second nut from the other end of the shaft (Figure 6).

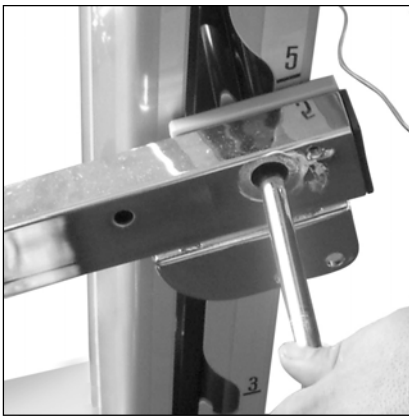
Figure 7

When both LAT Bars are removed, slide the rail shaft out one side (Figure 7) until it is completely removed from the round bushing on the far side of the tower (Figure 8).

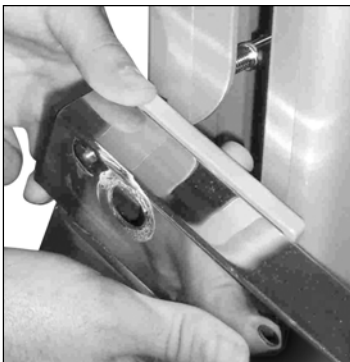
Figure 9

Remove the bushings from the rail by lifting the rail and sliding the bushing forward into the tower slot (Figure 9). The bushing can then be lowered below the rail (Figure 10).

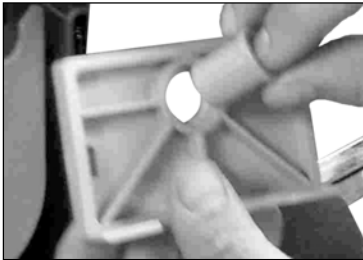
Figure 11

Install a new round bushing into the rectangular bushing (Figure 11). (If the rectangular bushing is of the solid type, replace it with the new ribbed acetyl bushing.) Slide the replacement bushings into the tower slot beneath the rail (Figure 12).

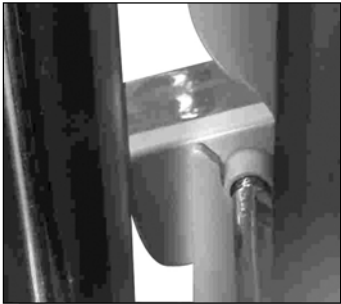
Figure 13

Lift the rail while you slide the bushing over the hook in the tower (Figure 13). Insert the rail shaft into the new bushing and slide it through the rail (Figure 14). Safety hint: aim the shaft into the bushing from the opposite side of the tower (Figure 15). Do not guide the rail shaft into the bushing with your finger. Always keep fingers clear of moving parts.

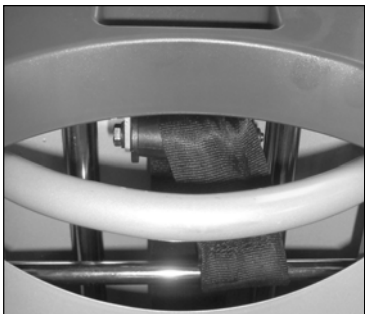
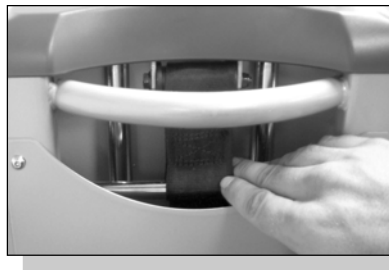
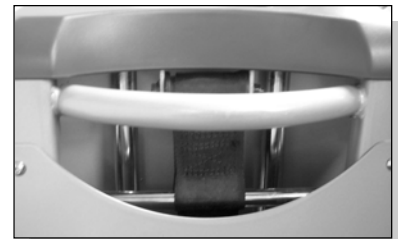
Repeat the process on the other side and reinstall the LAT Bars. When both LAT Bars are re-installed, raise the rails to the top level to center the counter weight belt (as shown below).
